COUNTY DRAINS IN THE GALIEN RIVER WATERSHED

Site Ecological Summary

Site Name: Galien River
County (s): Berrien
Size: 3800 acres, 6 mi²
Great Lakes shoreline: 0 miles
Rivers/streams: 68 miles

Galien River Road Stream Crossing Summary

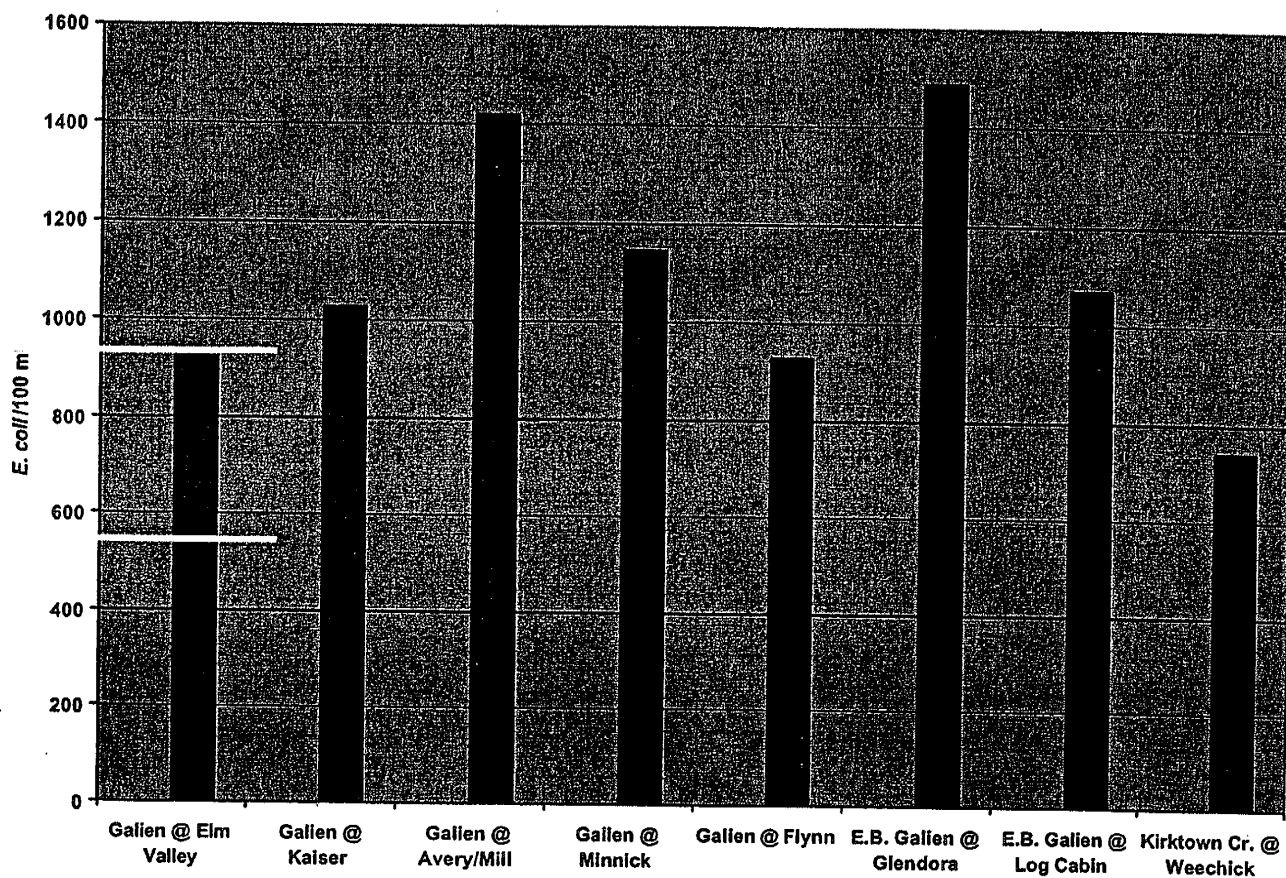
Figure 3. Seasonal geometric mean *E. coli* results for the Galien River and selected tributaries, Berrien County, Michigan, May through September, 2001. Data are presented upstream to downstream, followed by tributaries.

Based on 2001 monitoring data, the background concentration of *E. coli* was found to be exceeding the WQS. This conclusion was the basis for redefining the TMDL reach with an extended source area. Additional data will be collected during the 2002 sampling season to document existing conditions. The guiding water quality management principle used to develop the TMDL was that compliance with the numeric pathogen target in the Galien River depends on the continued control of point source *E. coli*, and the control of *E. coli* in storm water, illicit connections, and agricultural inputs. If the *E. coli* inputs can be controlled, then total body contact recreation in the Galien River will be protected.

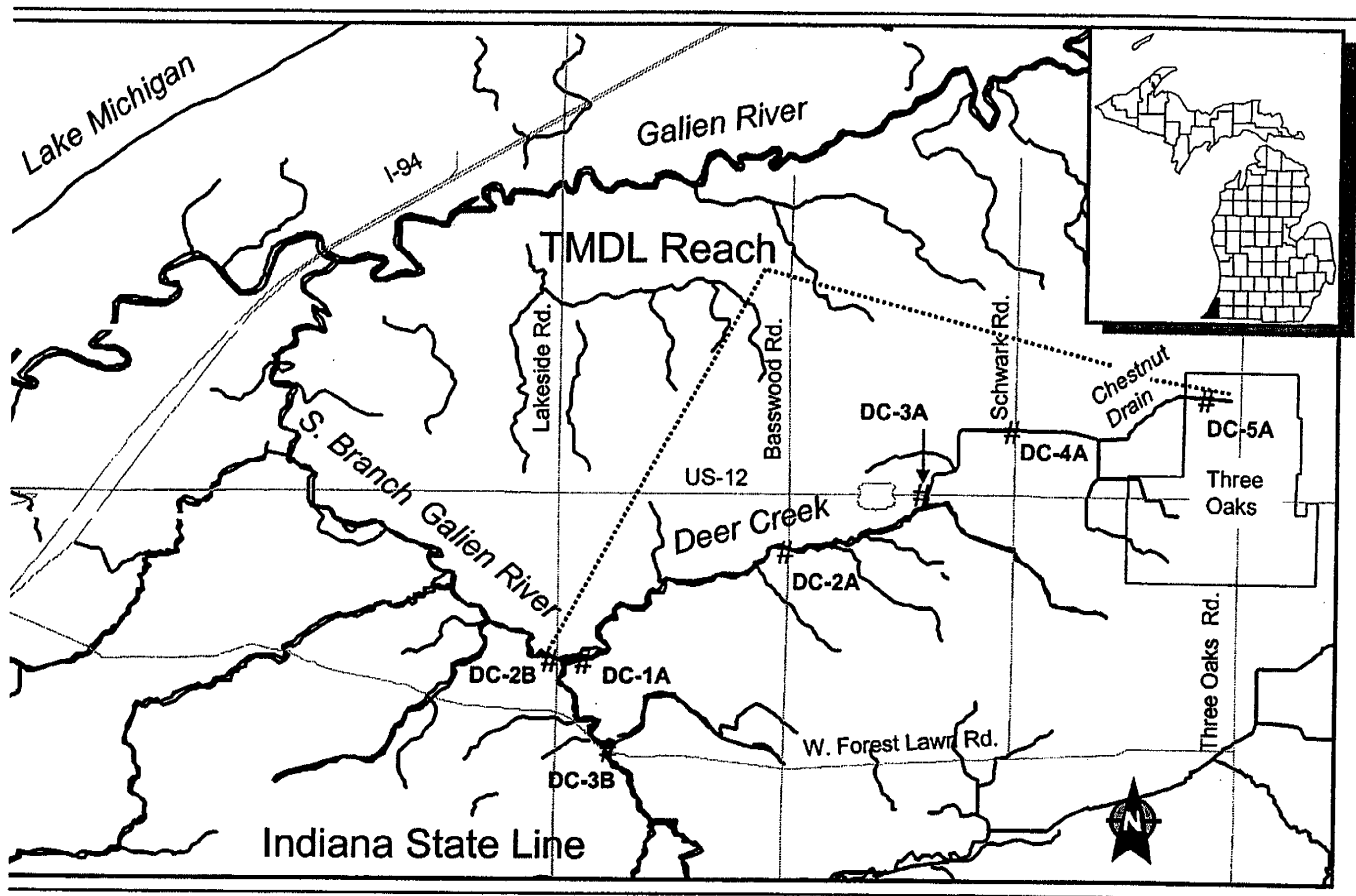
DC-1A = Deer Creek @ Lakeside Rd.
DC-2B = S. Branch Gallien River @ Lakeside Rd.
DC-3B = S. Branch Gallien River @ Forest Lawn Rd.
DC-4A = Deer Creek @ Schward Rd.
DC-5A = Chestnut Dr. in Three Oaks

Figure 1. Deer Creek *E. coli* sampling locations, vicinity of Three Oaks, Michigan, 2001.

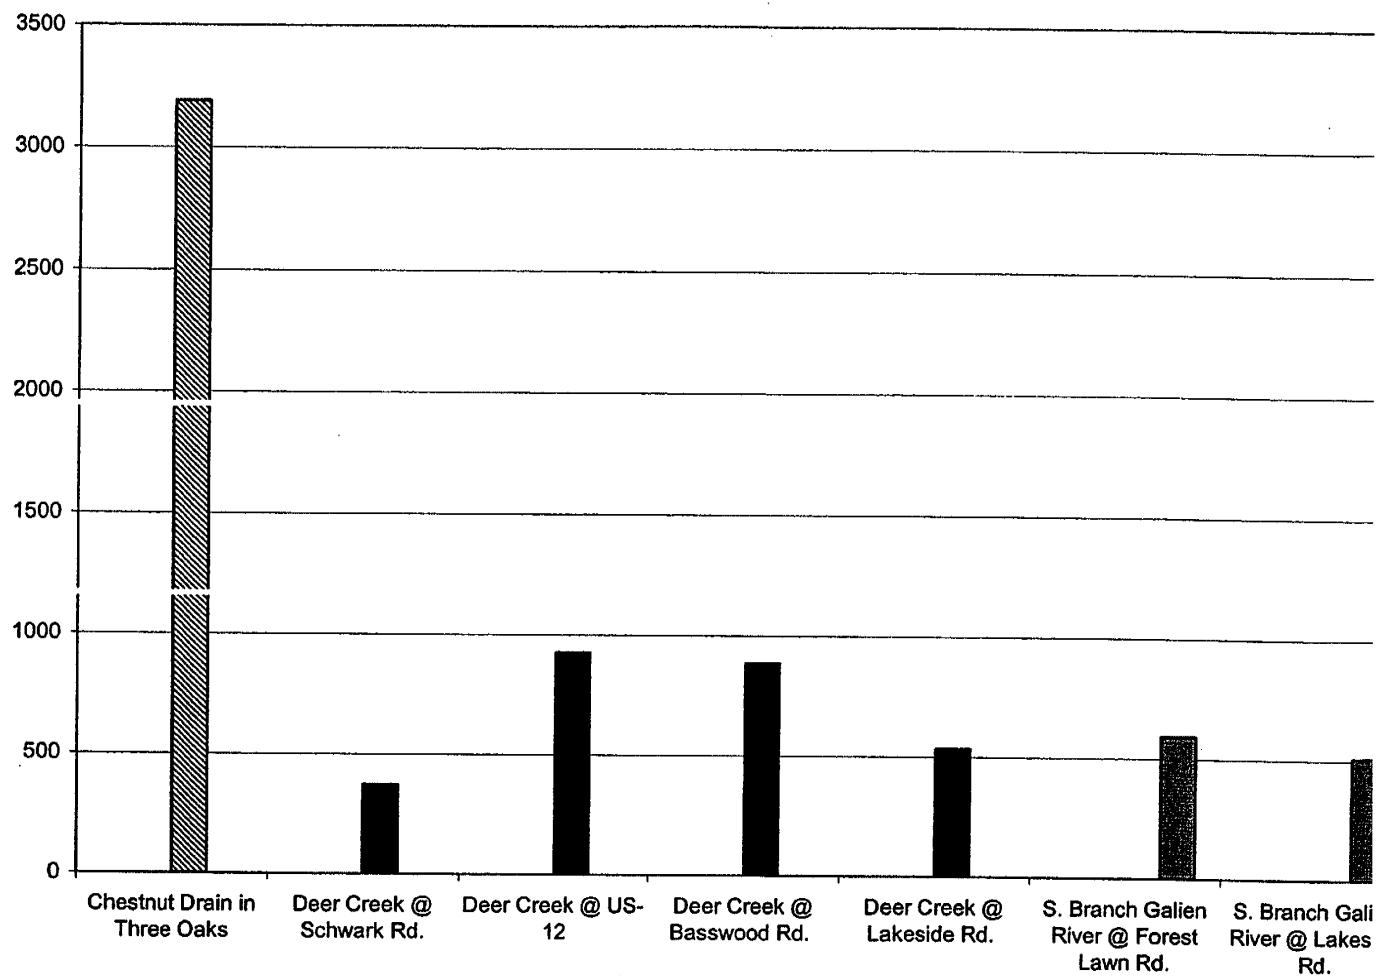
Figure 2. Geometric mean *E. coli* results from Deer Creek and related waterbodies, vicinity of Three Oaks, Three Oaks Township, Michigan, 2001.

Slightly elevated levels of *E. coli* were found at both stations. Monthly geometric means at Forest Lawn Road (upstream) ranged from 334 *E. coli* per 100 ml in September to 698 *E. coli* per 100 ml in July. Monthly geometric means for *E. coli* at Lakeside Road (downstream) ranged from 266 *E. coli* per 100 ml in June to 730 *E. coli* per 100 ml in July.
